# SIDE GEAR WARRANTY COVERAGE

## Tuff Torq Dealer Notification

**November 18, 2022**

Customer satisfaction has always been a prime concern of Tuff Torq. Therefore, we would like to call your attention to a potential issue with our K46, TL200 and K57 models.

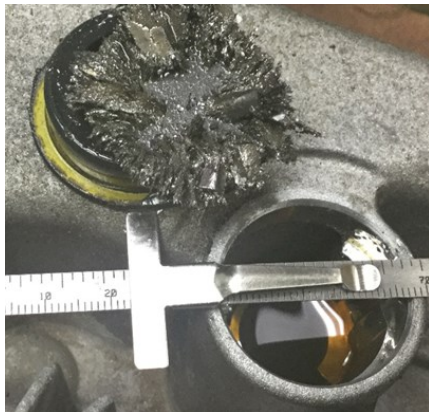
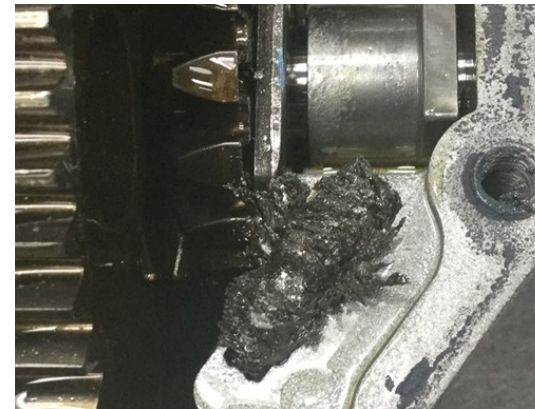
Remove top sealing cap (187T01-36300) and inspect magnet for large amounts of debris. If present, drain oil, remove lower housing and inspect magnet for debris.

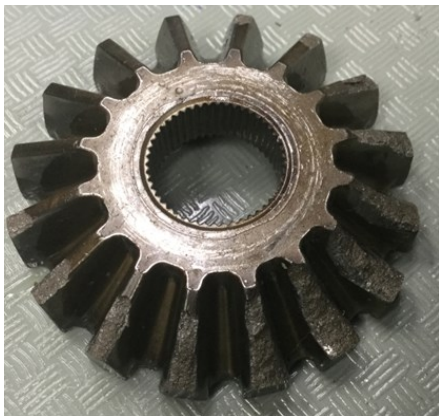
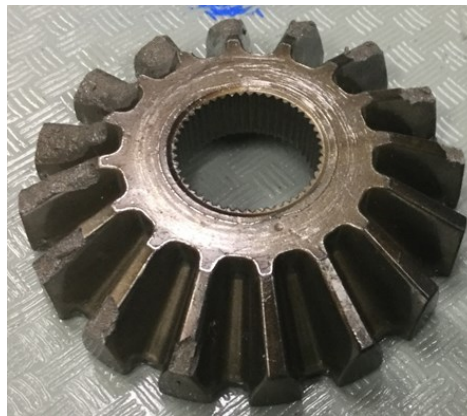
Tuff Torq Corporation has discovered that a small number of transmissions were manufactured with a differential side gear, 168T20-31560, that does not meet specifications. While the chances are low, this could lead to premature failure of the gear early in the life of the transaxle, resulting in possible loss of propulsion and braking. Because of this issue, any transmission issues caused by the failure of differential side gear 168T20-31560 should be replaced at no cost to the customer regardless of the warranty period.

If present, inspect differential side gears for heavy wear or missing portions of the teeth.

If the issue is present, replace the transaxle under normal warranty procedure. If you have any questions, please contact Tuff Torq Service Department. 423-585-2160 or [gearwarrantycoverage@tufftorq.com](mailto:gearwarrantycoverage@tufftorq.com)

To receive payment outside the original warranty coverage, the two differential side gears must be returned to Tuff Torq when filing the warranty.
